Simulation of cement removal on titanium surfaces

C. Trempler*, M. Behr and G. Handel

(Department of Prosthetic Dentistry, University Medical Center Regensburg, Germany)

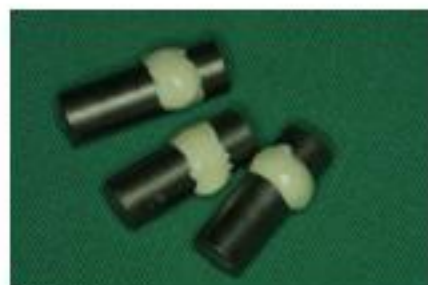
Fig. 1: Samples with cement

The clinical procedure of cement removal was simulated using a model with titanium beams of 6mm diameter. Three investigators cleaned up 6 specimens which had a standardized layer of #1 zinc phosphate (Harvard, Hoffmann, Berlin, G), #2 glass ionomer (Ketac Cem, 3M ESPE, Seefeld, G), #3 resin cement (Calibra, Dentsply, Milford, USA), #4 self-adhesive composite cement (RelyX Unicem, 3M ESPE, Seefeld, G), or a #5 provisional eugenol-free cement (Provicol, Voco, Cuxhaven, G) using steel or plastic scalars. Each specimen was treated for 30sec under blinded standardized conditions. The cleaned surfaces were digitally recorded and cement remnants were evaluated using an image analysis program (Optimas Corporation 6). Statistical analysis: Mean, standard deviation, ANOVA.

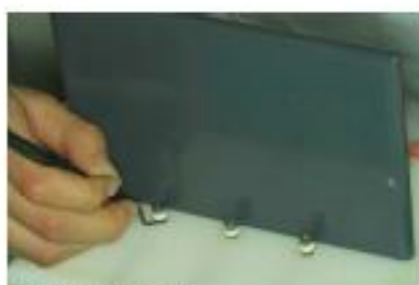
Fig. 2: Simulation of cement removal

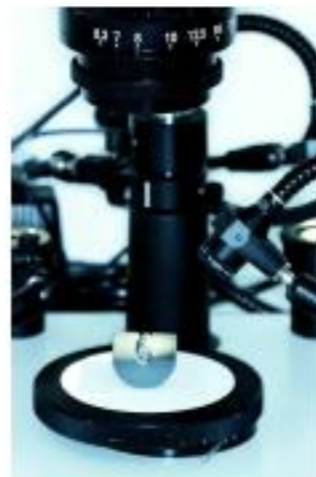
Fig. 3: Sample under the digital microscope

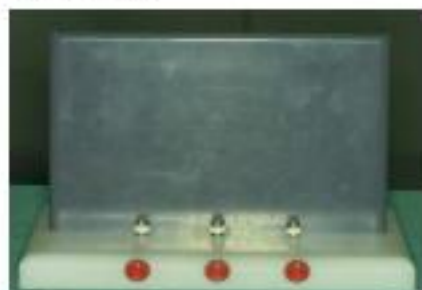
Fig. 4: Fixation unit

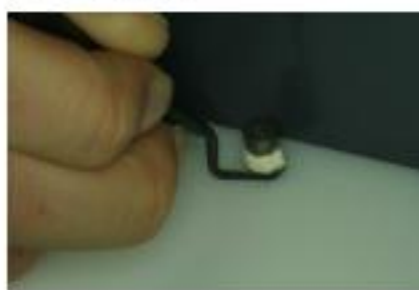
Fig. 5: Simulation of cement removal

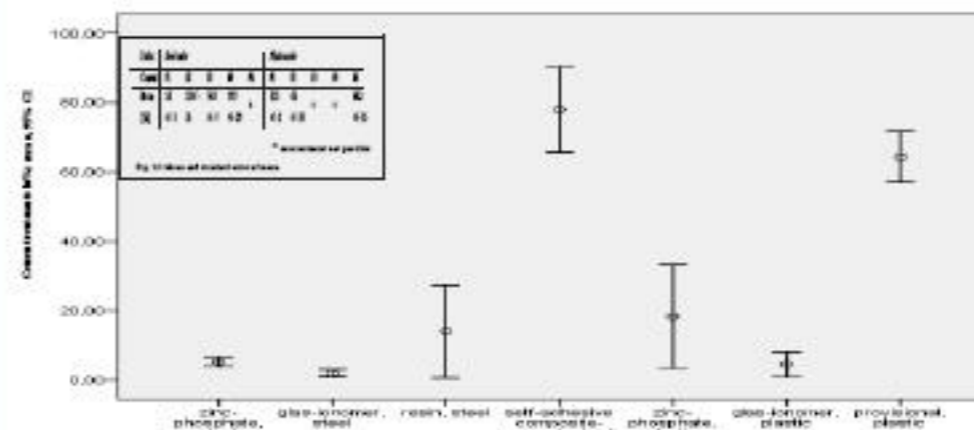
Fig. 11: Cement remnants in %

Surplus of cement was found on all specimens after cleaning. The amount of remnants depended on the investigated cement and scaler type. Glass ionomer cement processed with a steel scaler showed significant less remains ($p=0.05$). However, in some cases glass ionomer cleaning was quite difficult, which explains the high standard deviation. Self-adhesive composite and provisional cement showed significant higher amounts of cement remnants after the cleaning procedure ($p<0.001$).
